# **Ice-Affected Components of Locks and Dams**

Andrew M. Tuthill February 2002

# Technical Report ERDC/CRREL TR-02-4

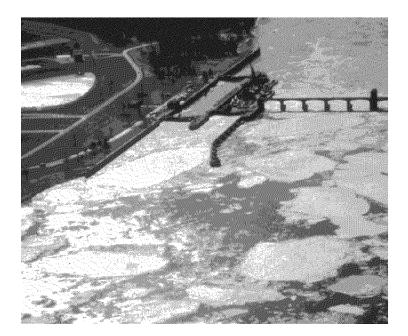
Figure 3. Ice accumulation in the upper approach at Lock and Dam 21 on the upper Mississippi River.

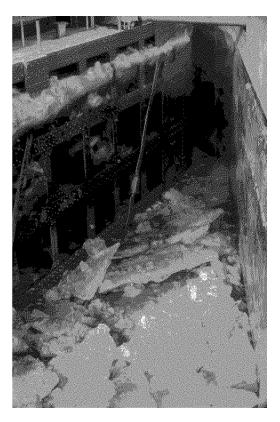
Brash in the miter gate recesses greatly hinders winter operation by preventing the miter gates from fully opening (Fig. 5). Once this situation begins to occur, the Corps may require the barge industry to limit the length and width of its tows, a measure that greatly reduces the cargo capacity of the waterway system. Locking tows in ice with partially opened miter gates is not

Figure 5. Brash ice in the miter gate recess.

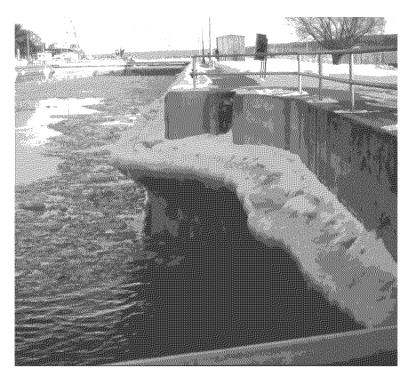
Figure 7. Ice collars in the gate recess and on the lock wall.

Lock walls, like the gate recesses, are extremely susceptible to icing and the formation of ice collars. With repeated wetting from the lowering and raising of the chamber, the ice adheres extremely well to the worn concrete and steel rub plates typical of many Corps locks. The thickest buildups typically form at the high pool level and can achieve widths of greater than 3 ft, preventing 105-ft-wide tows or vessels from entering 110-ft-wide locks (Fig. 7). Typically, lock wall icing is more severe on north-facing than south-facing walls due to the beneficial effect of solar radiation. Some believe that ice collar formation can be reduced by keeping the chamber at high pool when not in use.\* A possible explanation is that, at high pool, most of the wall area is submerged and therefore protected from subfreezing air temperature.

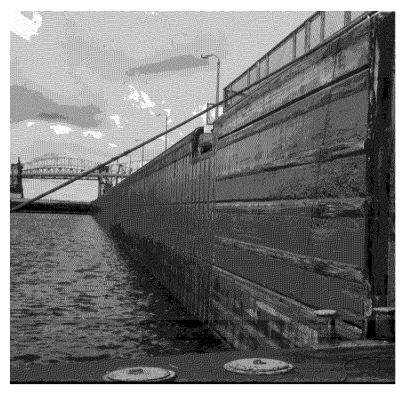
The most effective solution for deicing large areas was the copolymer coating tested at the Soo locks in 1979, during the Winter Navigation Program (Frankenstein and Hanamoto 1983) (Fig. 8). The coating was relatively costly to apply, though, requiring steam cleaning of the lock wall and an epoxy undercoat. To remove the ice, some steaming was required, but the ice came off the coated lockwall much more easily than from untreated concrete. Within a few years, vessels had scraped off most of the coating, and it was not reapplied because of cost and the fact that winter-long operation of the Soo Locks has been discontinued.

Figure 8. Copolymer coating at the Soo Locks.

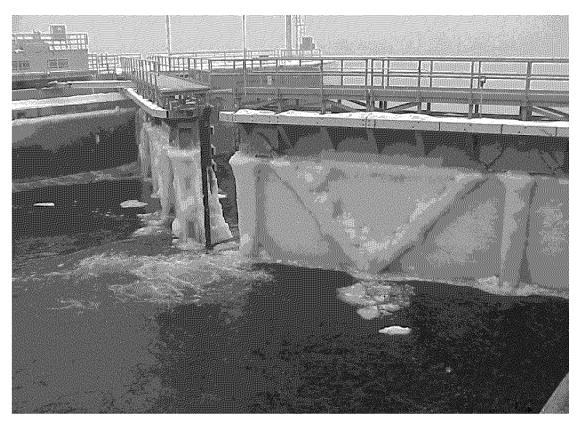
Figure 10. Miter at Lock 24 on the upper Mississippi with widely spaced structural members on the upstream side.

downbound tows would push ice into the lock and pack it into the trusswork on the upstream side of the lower gates. Protruding ice would have to be removed with great difficulty before the gates could be fully recessed. Replacement miter gates with the steel skinplate on the upstream rather than the downstream side have solved this problem at Marseilles and Dresden Island Locks, on the Illinois Waterway. In addition to eliminating the trusswork icing problem, the gate is thinner, providing about 12 inches of clearance between the skinplate and the recess wall.

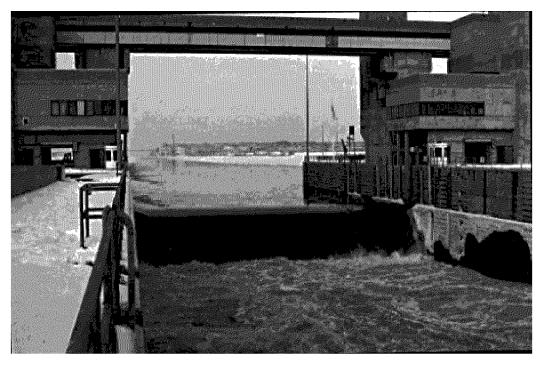
Skimming ice, though effective, carries potential hazards. For example, during the winter of 2001, while running ice through the main lock chamber at Mel Price, one of the downstream miter gates was caught by the current and swept past the miter gate sill. Until then, operators had relied on the hydraulic pistons, rather than latching mechanisms, to hold the gates open while flushing ice. The repairs took four months, forcing one of the busiest navigation projects in the nation to rely on a

Figure 12. Submergible lift gate at Mel Price Lock.

single 110-ft by 600-ft lock chamber. A possible explanation is that ice in the miter gate recess prevented the gate's full opening, causing it to protrude into the flow.

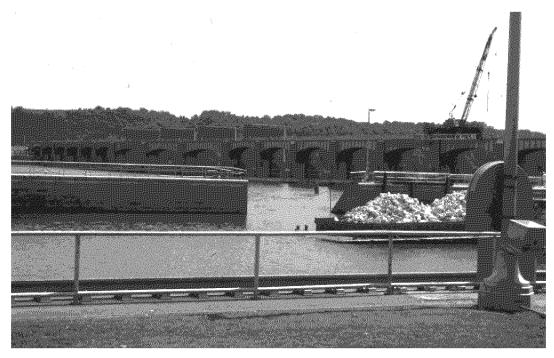
Figure 13. Drift pass in the river guardwall being widened at Lock and Dam 25 on the upper Mississippi.

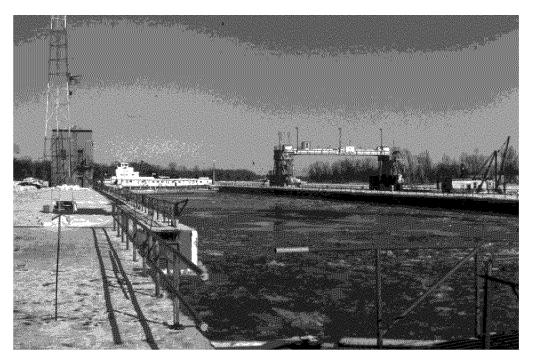
Ice passage from the upper approach to dam gates is more feasible on the Illinois Waterway where, instead of a continuous river guardwall, isolated mooring cells prevent tows from drifting towards the dam. Depending on the plan configuration of the cells, it may be possible to pass ice from the upper approach between the cells to adjacent gates. This is the case at Peoria and Le Grange Locks, which are equipped with submergible tainter gates adjacent to the locks that regulate pool height and clear ice from the upper approach (Fig. 14).

Figure 14. Le Grange Lock and Dam on the Illinois River. A free towboat washes brash ice from the upper approach, towards the submergible gate, adjacent to the lock chamber.

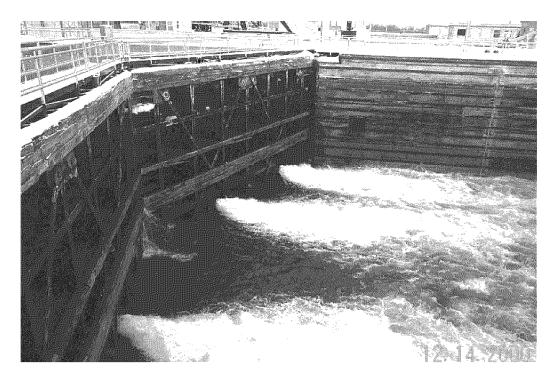
At the Soo Locks, four 60-cm-diameter manifolds, installed in the upper miter gates at the low-pool water level, create horizontal surface jets to move the ice out of the upper portion of the chamber (Fig. 15). Flow from the filling ports then creates sufficient downstream surface currents to flush the ice out of the middle-to-lower portion of the chamber.

Figure 15. Ice flushing manifolds at the Poe Lock, Sault Ste. Marie, Michigan.
